FYC & SS Shoreline Facilities Review

Presentation to members Nov 20, 2017

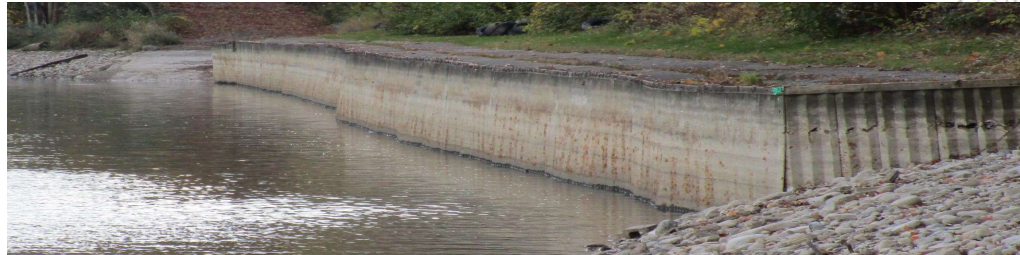
North end return deterioration – loss of backfill, opening joint, hazardous in board end

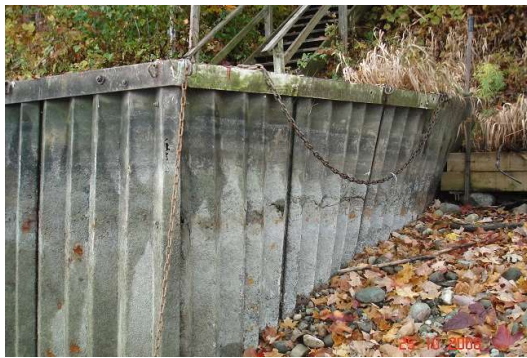
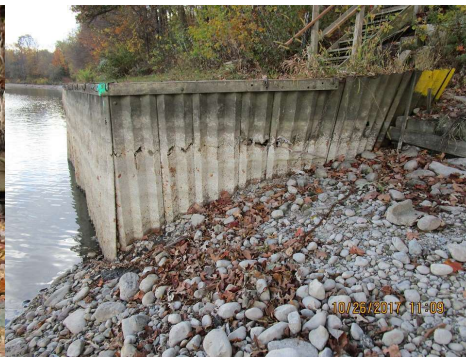
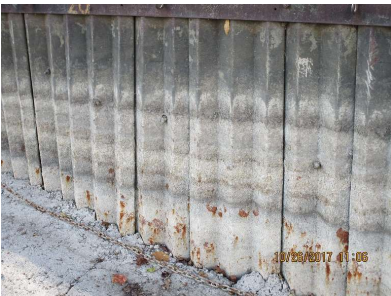
At Ramp

– 7 ties,
3 major tie back

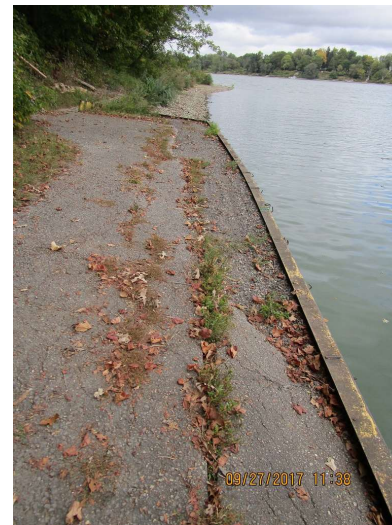
2015 - 2017 filling

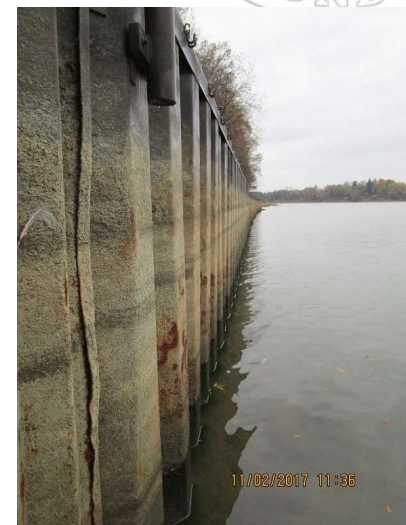
1992 new 50 ft. section

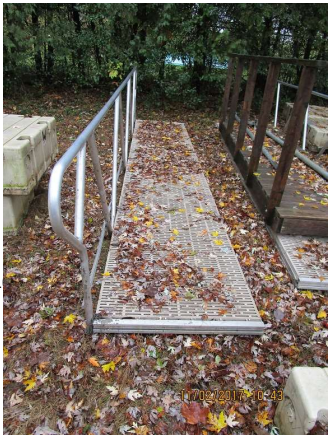
One of two railings on each ramp removed which were integral structural members

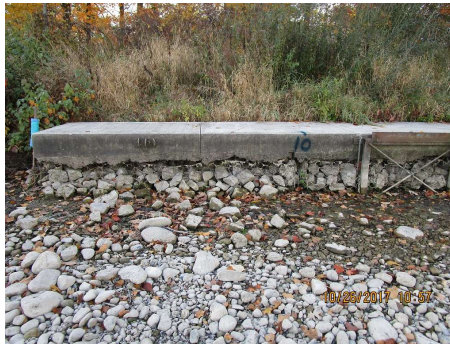
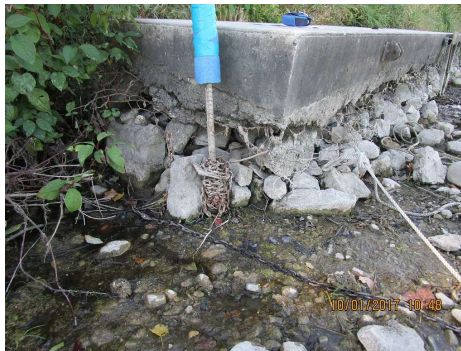
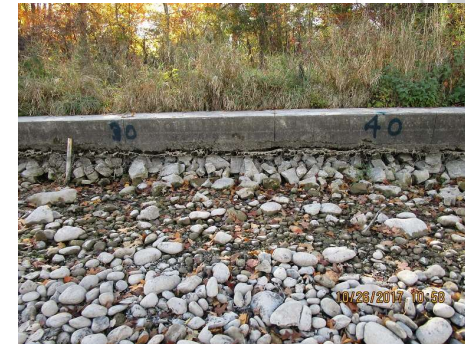
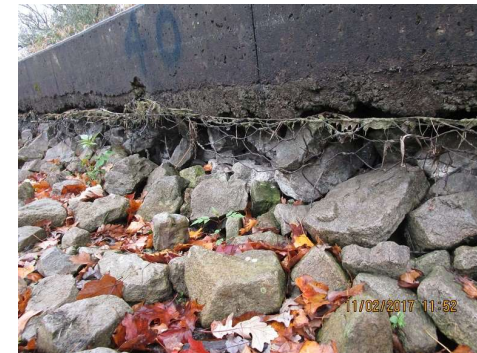
100 ft. walkway – 3 ft wide – 65 ft. of gabion wire broken – rocks spill
